Parcel Information:

Address: 378 DEPAUW CT | Parcel ID: 025-003160

Sidewalk Panel Detail

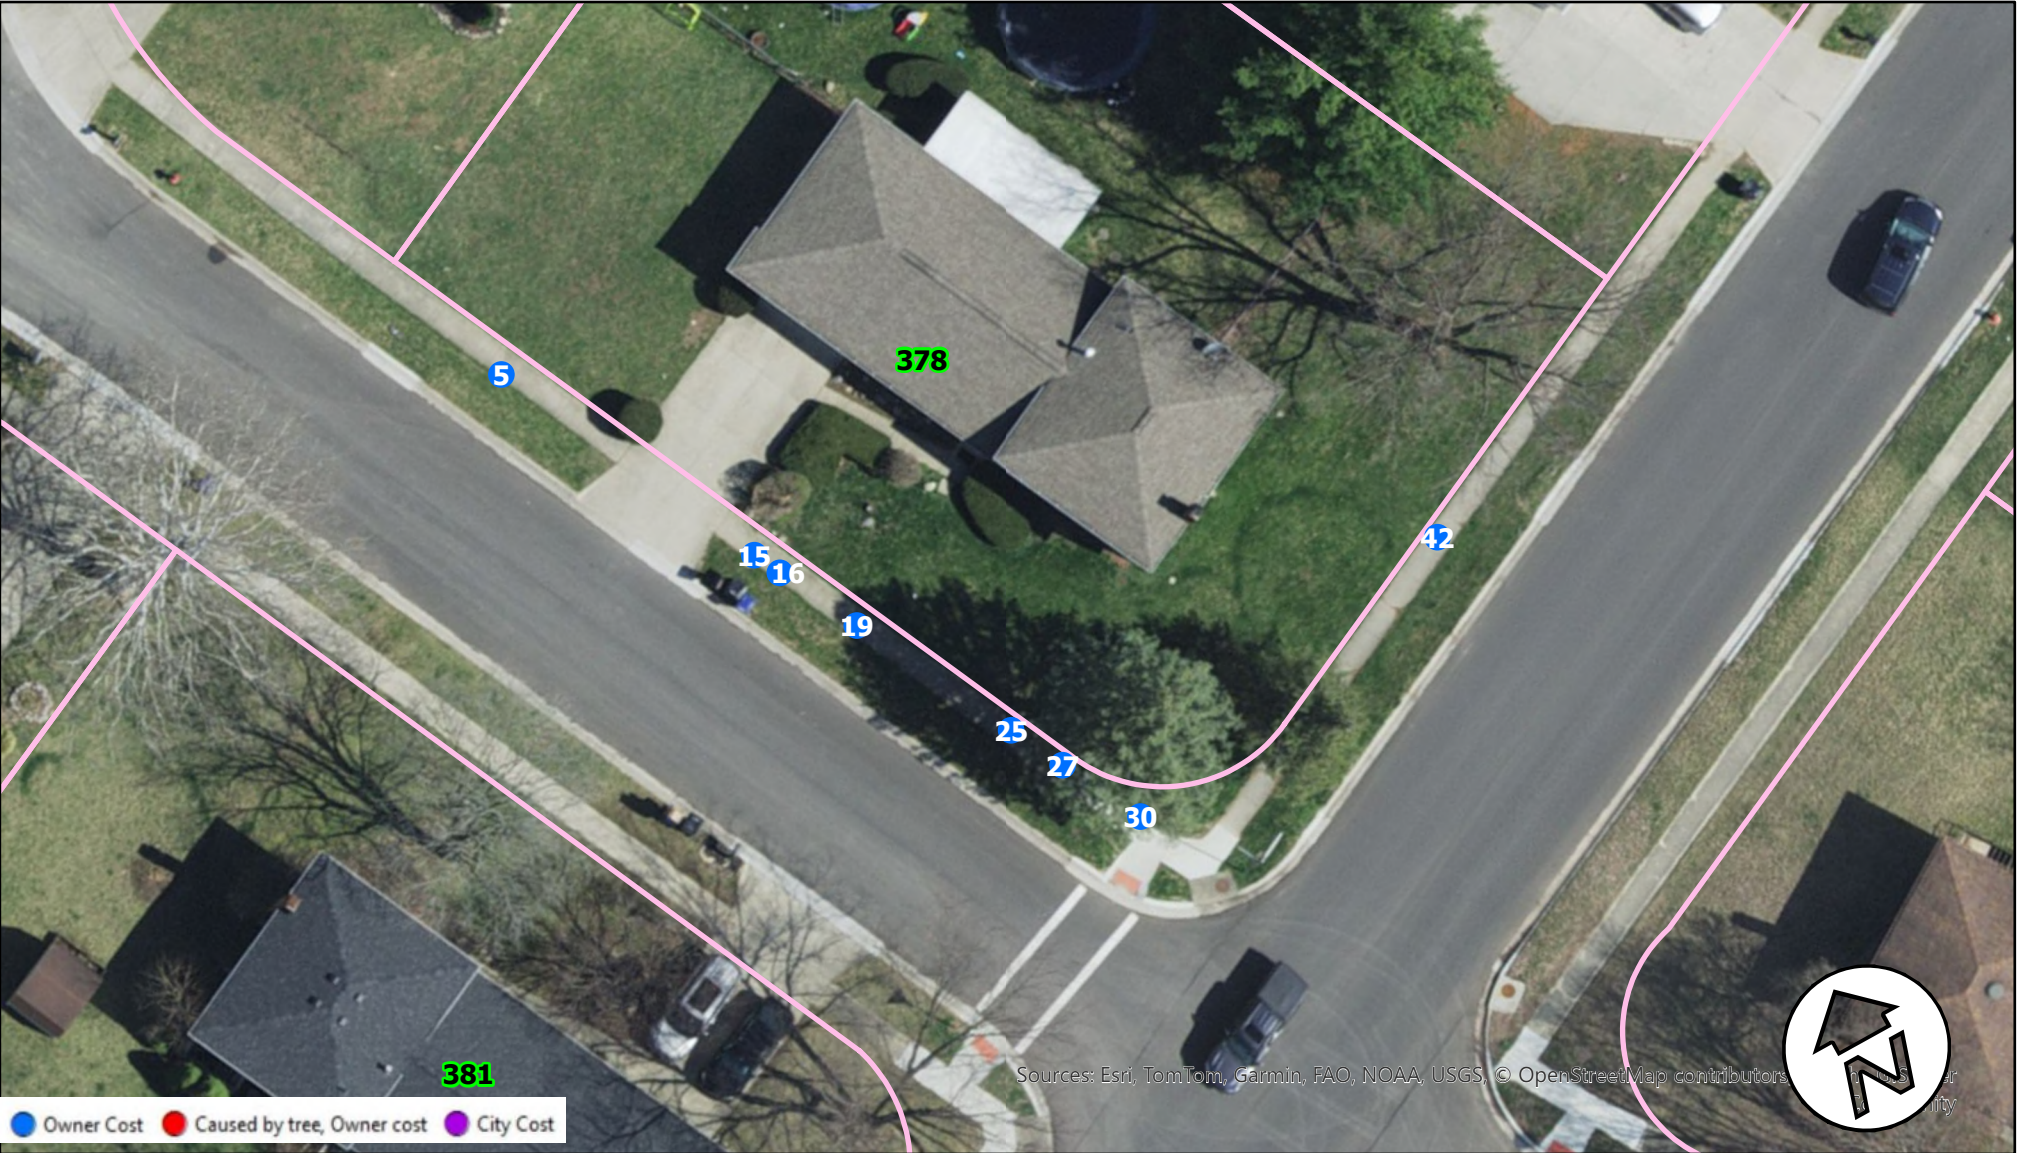
| ParcelPanelNumber | Panel Type | Responsibility | Defect | 4in Concrete Replacement (SF) | 6in Concrete Replacement (SF) | 8in Concrete Replacement (SF) | Grinding(LF) | Patch Asphalt (SF) | Patch Concrete (SF) | Vegetation (LF) | Root Pruning (Panel) |
| 5 | Sidewalk | Owner | E | 0 | 0 | 0 | 4 | 0 | 0 | 0 | 0 |
| 15 | Sidewalk | Owner | D | 17 | 0 | 0 | 0 | 0 | 0 | 0 | 0 |
| 16 | Sidewalk | Owner | D | 17 | 0 | 0 | 0 | 0 | 0 | 0 | 0 |
| 19 | Sidewalk | Owner | E | 0 | 0 | 0 | 4 | 0 | 0 | 0 | 0 |
| 25 | Sidewalk | Owner | A | 17 | 0 | 0 | 0 | 0 | 0 | 0 | 0 |
| 27 | Sidewalk | Owner | A | 17 | 0 | 0 | 0 | 0 | 0 | 0 | 0 |
| 30 | Sidewalk | Owner | A | 17 | 0 | 0 | 0 | 0 | 0 | 0 | 0 |
| 42 | Sidewalk | Owner | E | 0 | 0 | 0 | 4 | 0 | 0 | 0 | 0 |
