# Gahanna

DEPARTMENT OF ENGINEERING

APRIL 29, 2025

# Sidewalk Maintenance

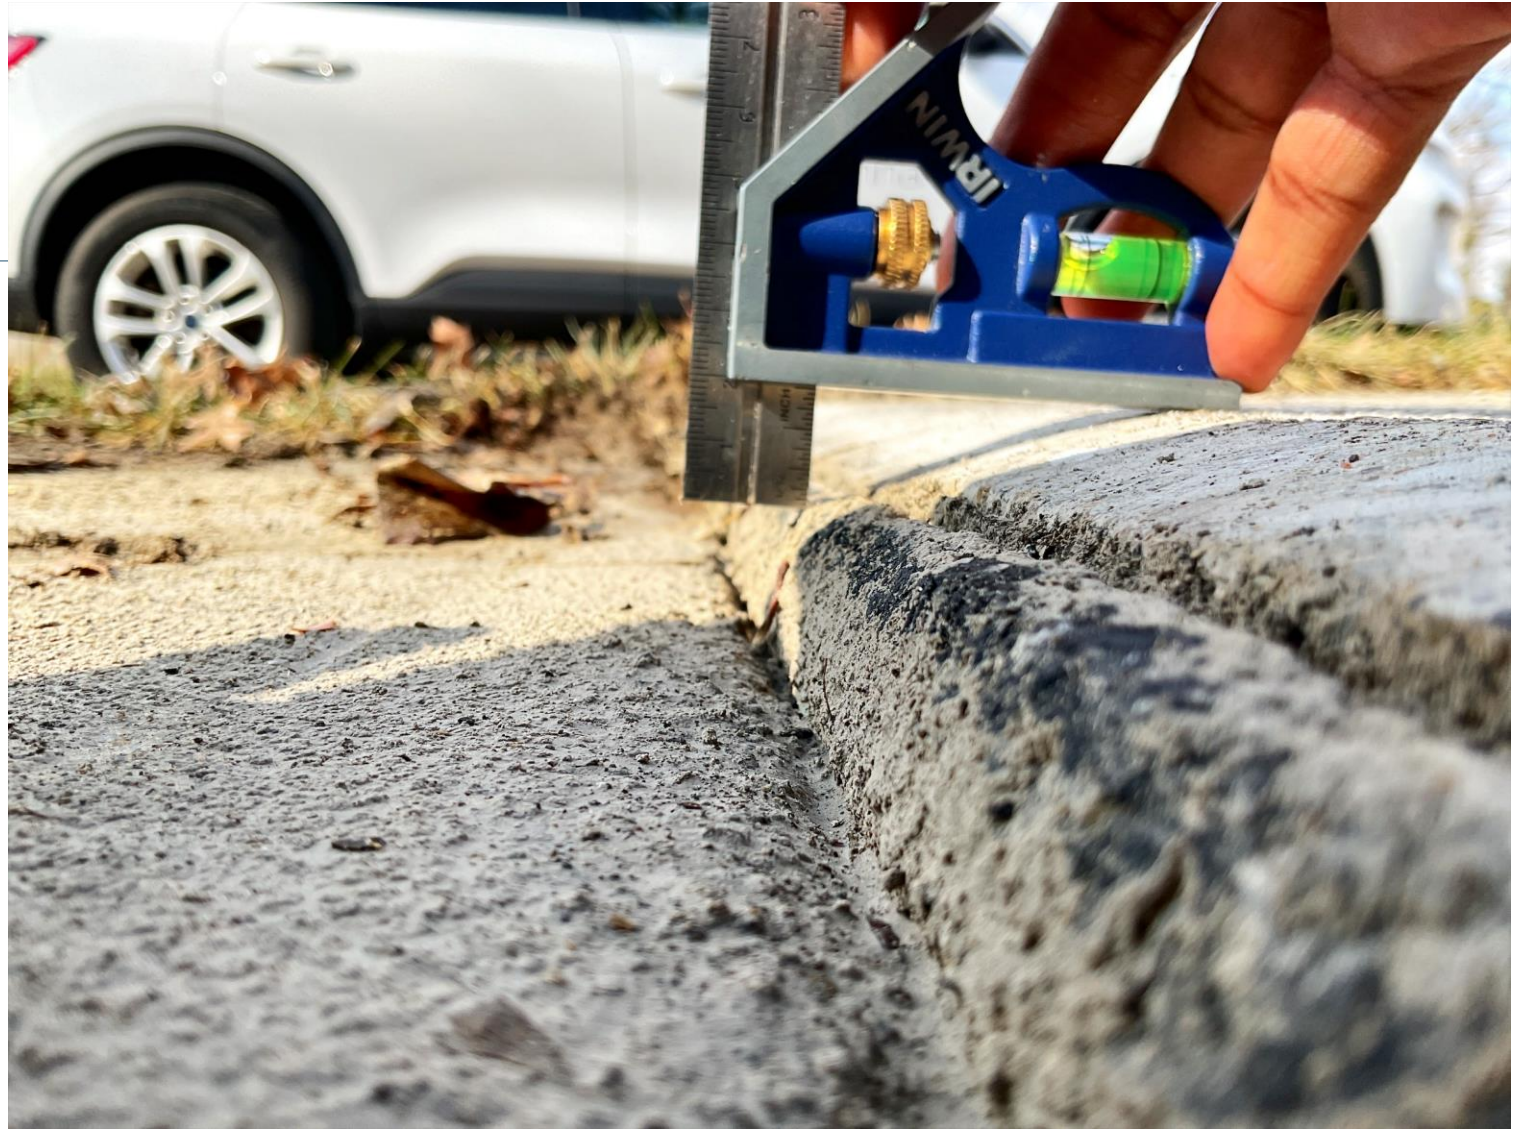
# Panel 9

Vertical offset still present  
In excess of  $\frac{3}{4}$ "

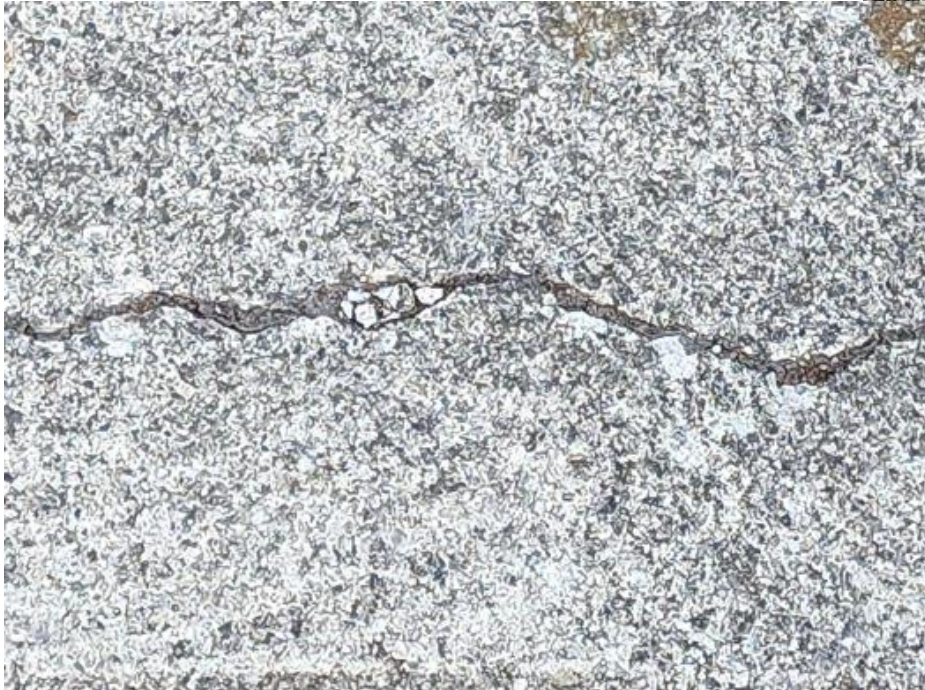
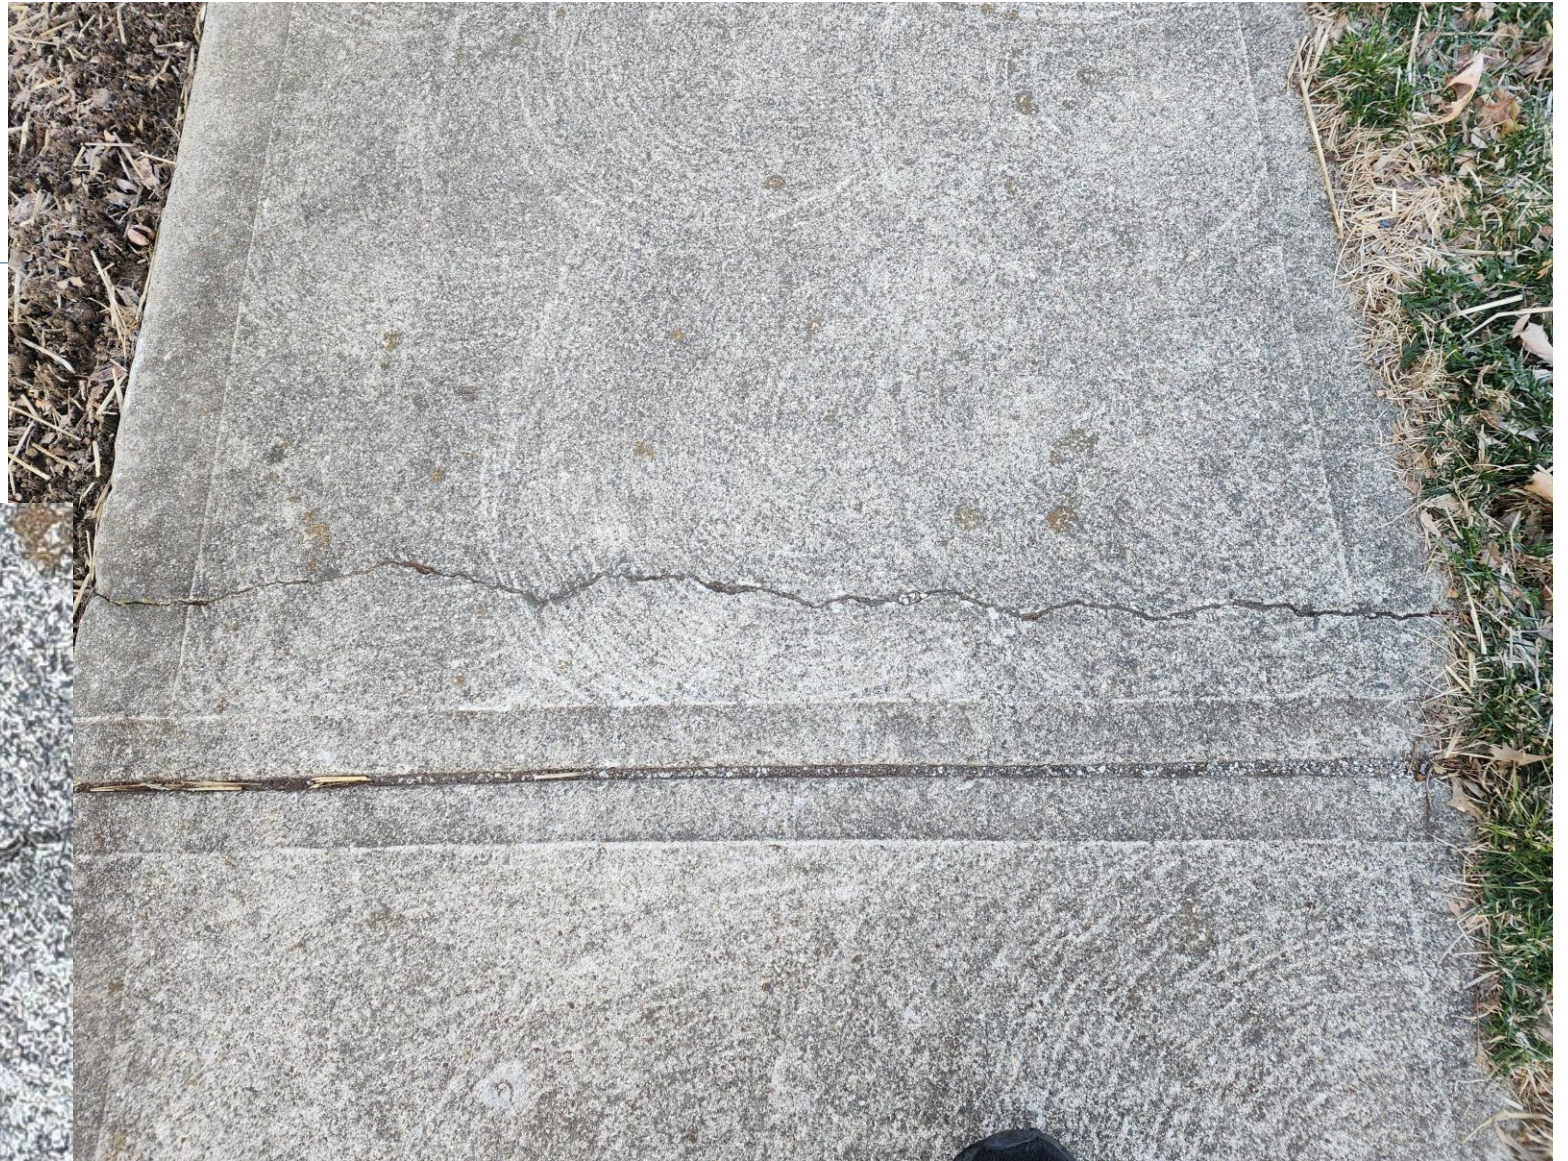
# Panel 11

Crack separating and  
starting to deteriorate

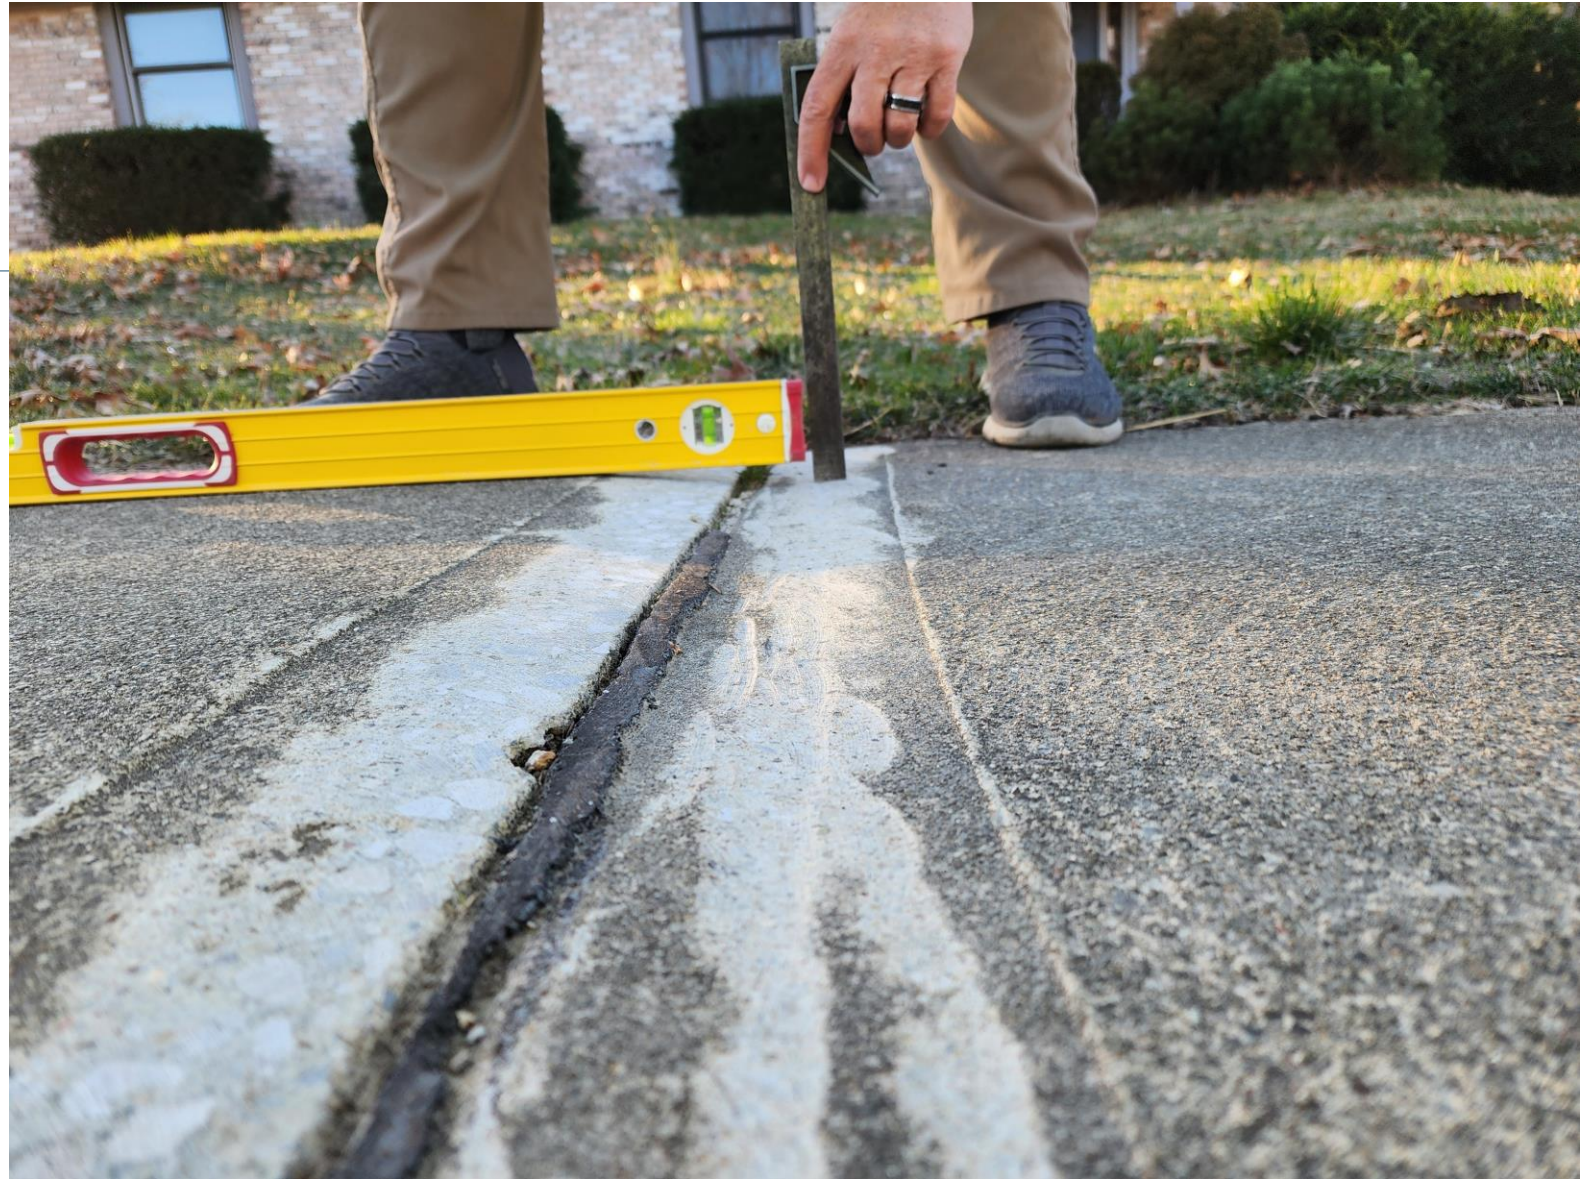
# Panel 17

Offset ground

May not meet  
PROWAG slope

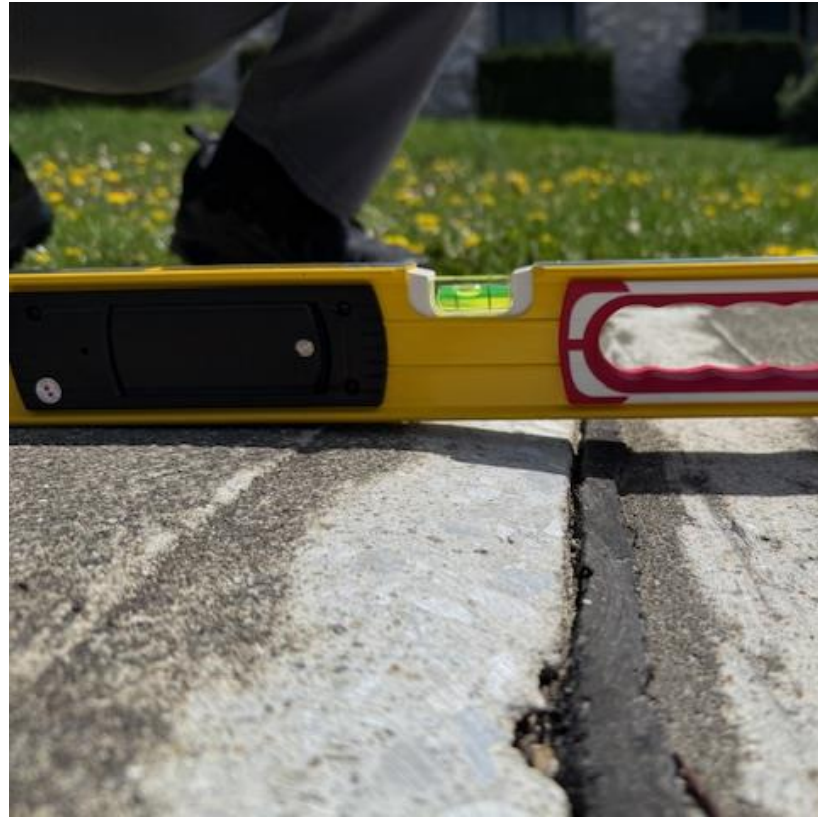
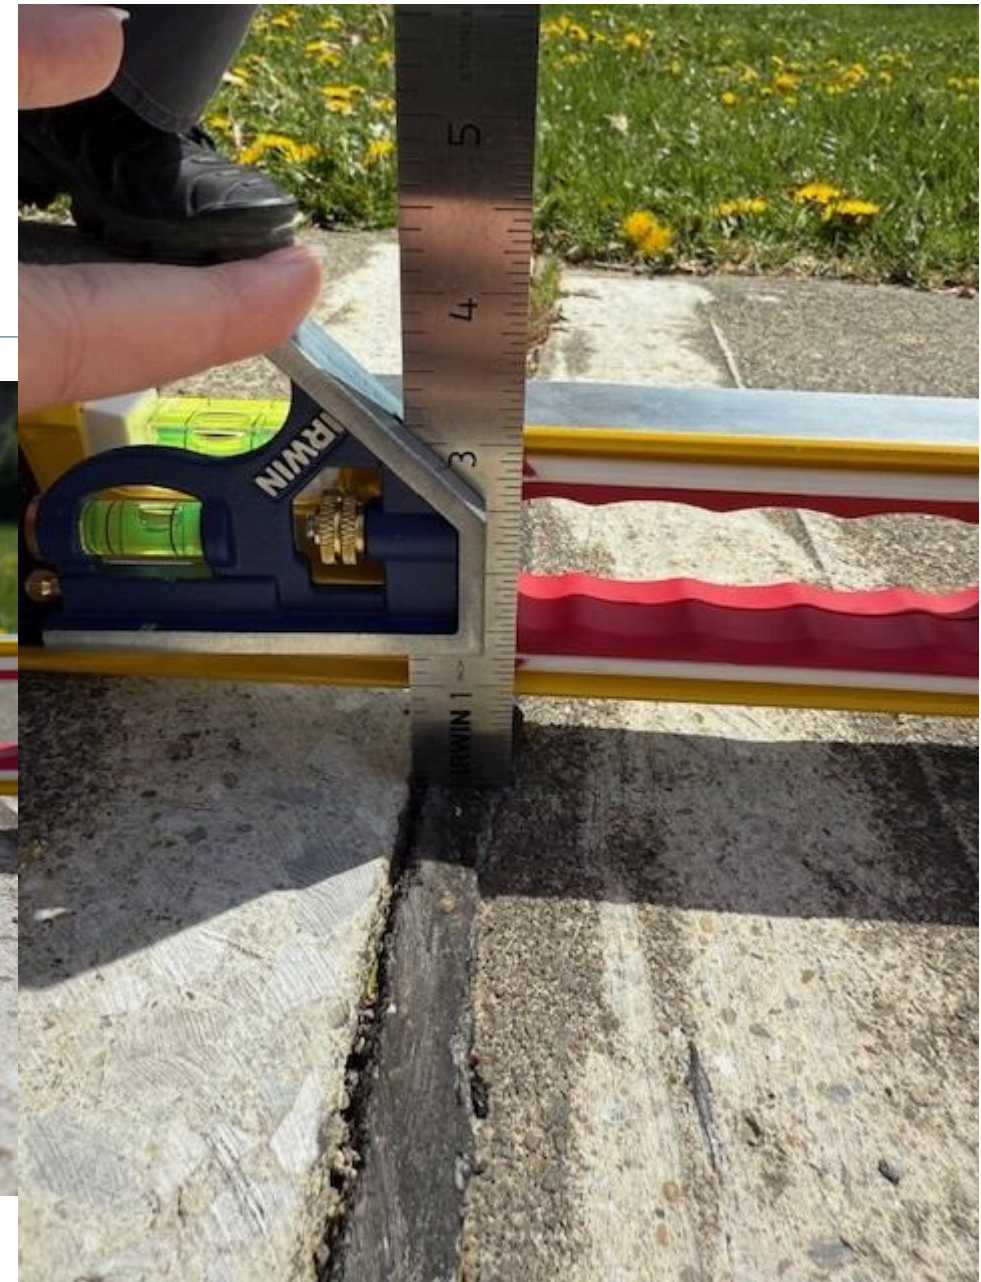
# Panel 17

Offset ground

Panel hump

present

1" at highest point

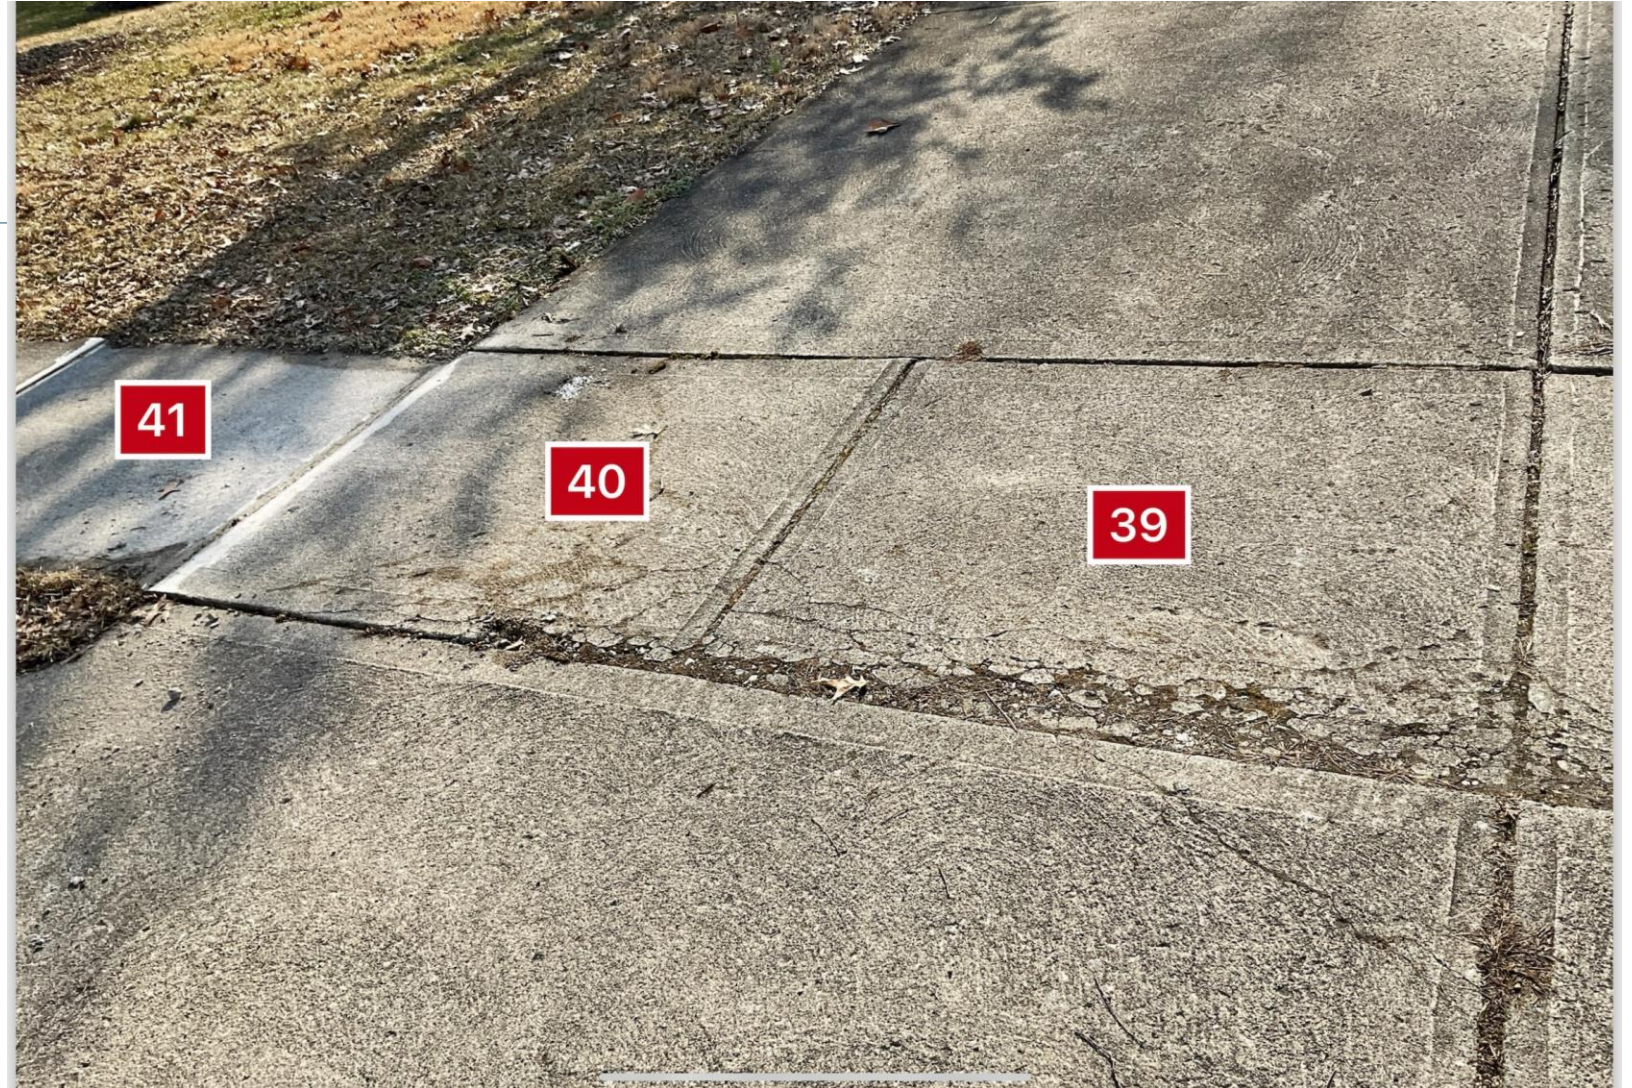
# Panel 39

Deterioration

Excessive Cracking

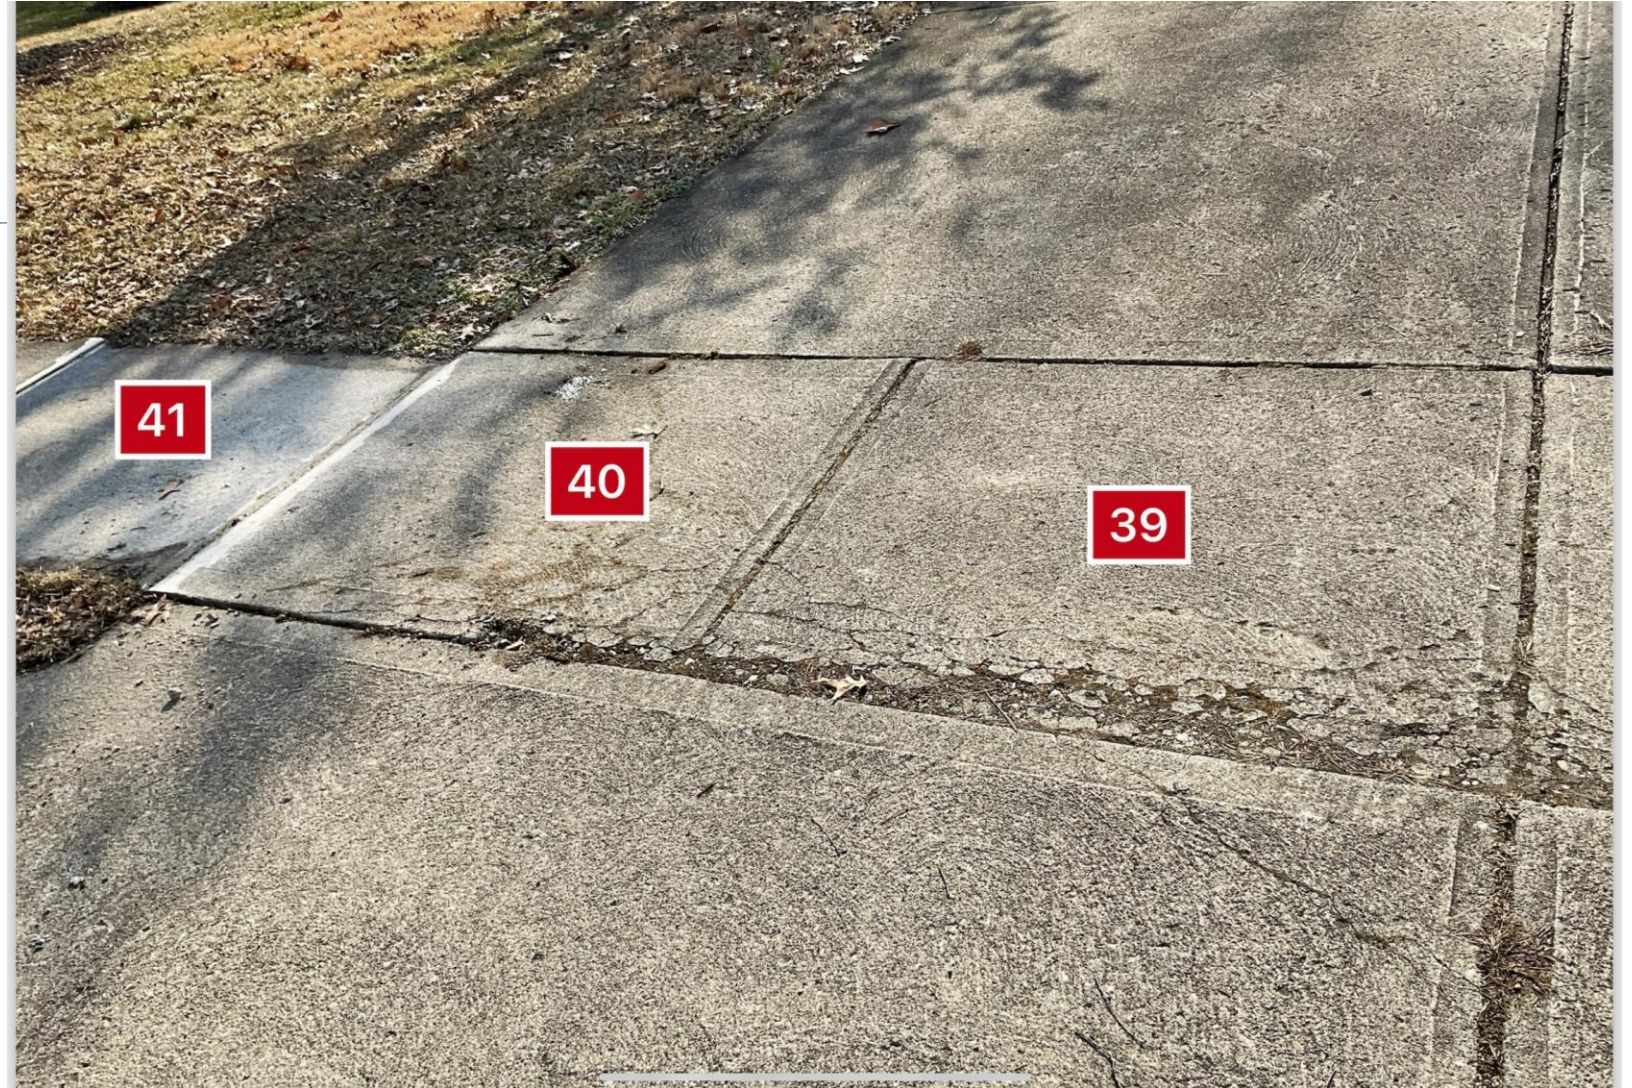
# Panel 40

Deterioration

Excessive Cracking

Offset between  
Panels 40 & 41

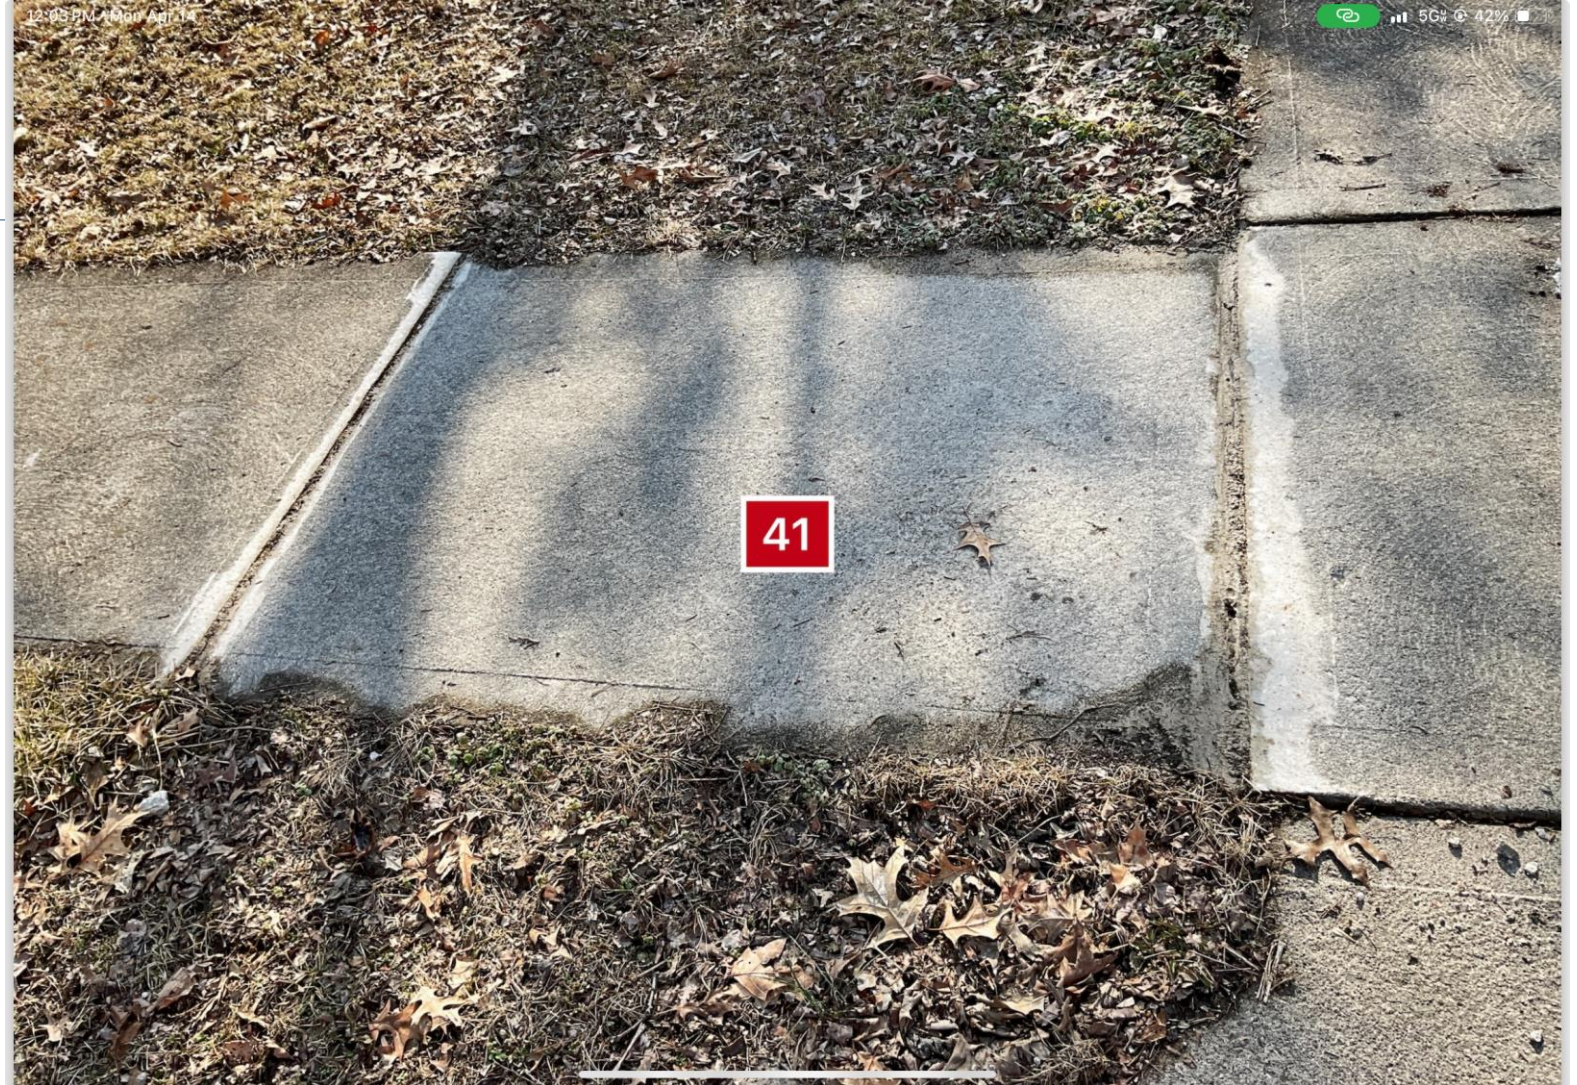
# Panel 41

Vertical offsets  
present on both sides

Panel recommended for  
full replacement to  
address both offsets

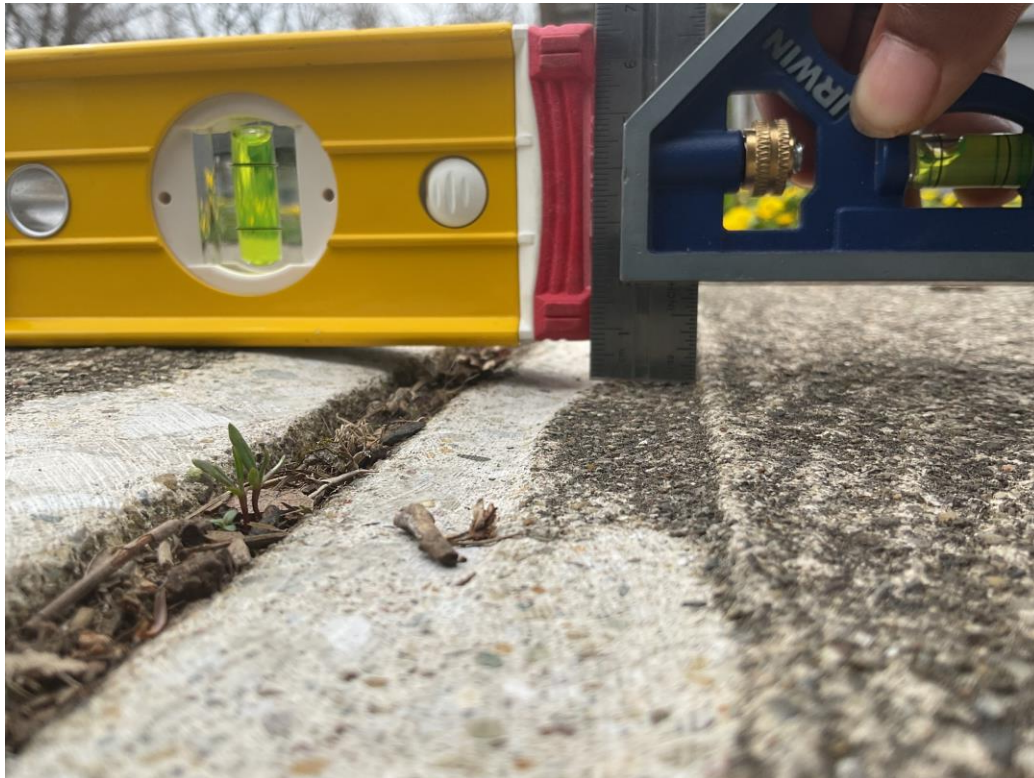
# Panel 41

11/16" offset

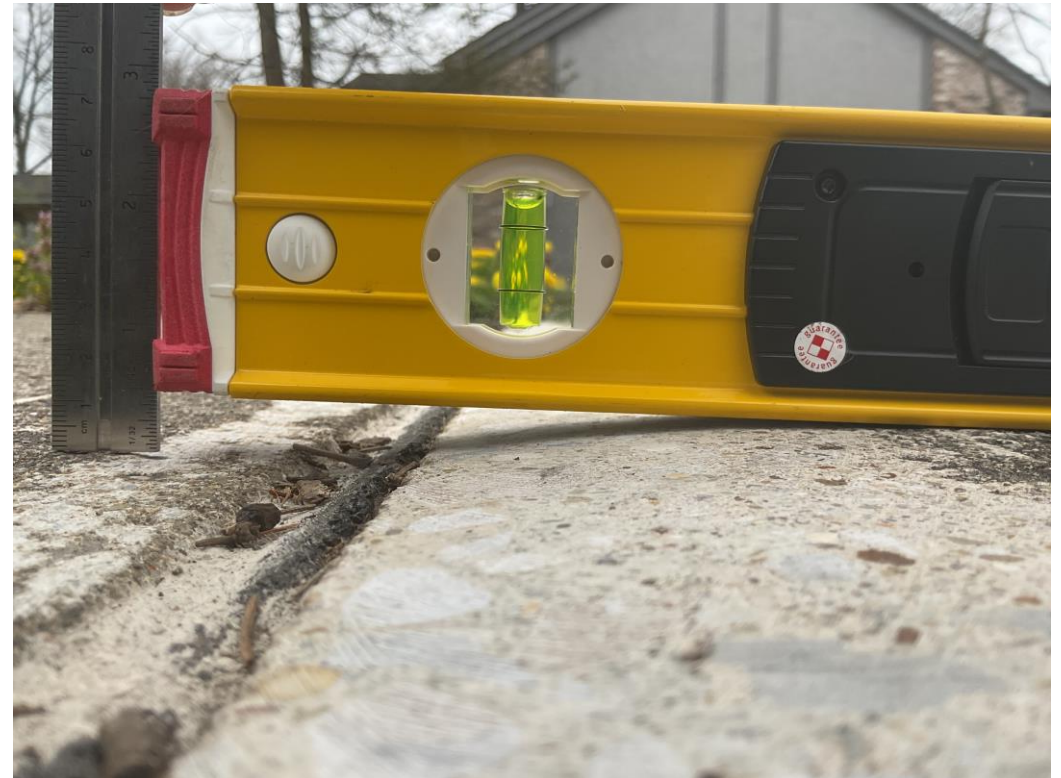
1" at highest point
