Parcel Information:

Address: 149 LANDOVER RD | Parcel ID: 025-004155

Sidewalk Panel Detail

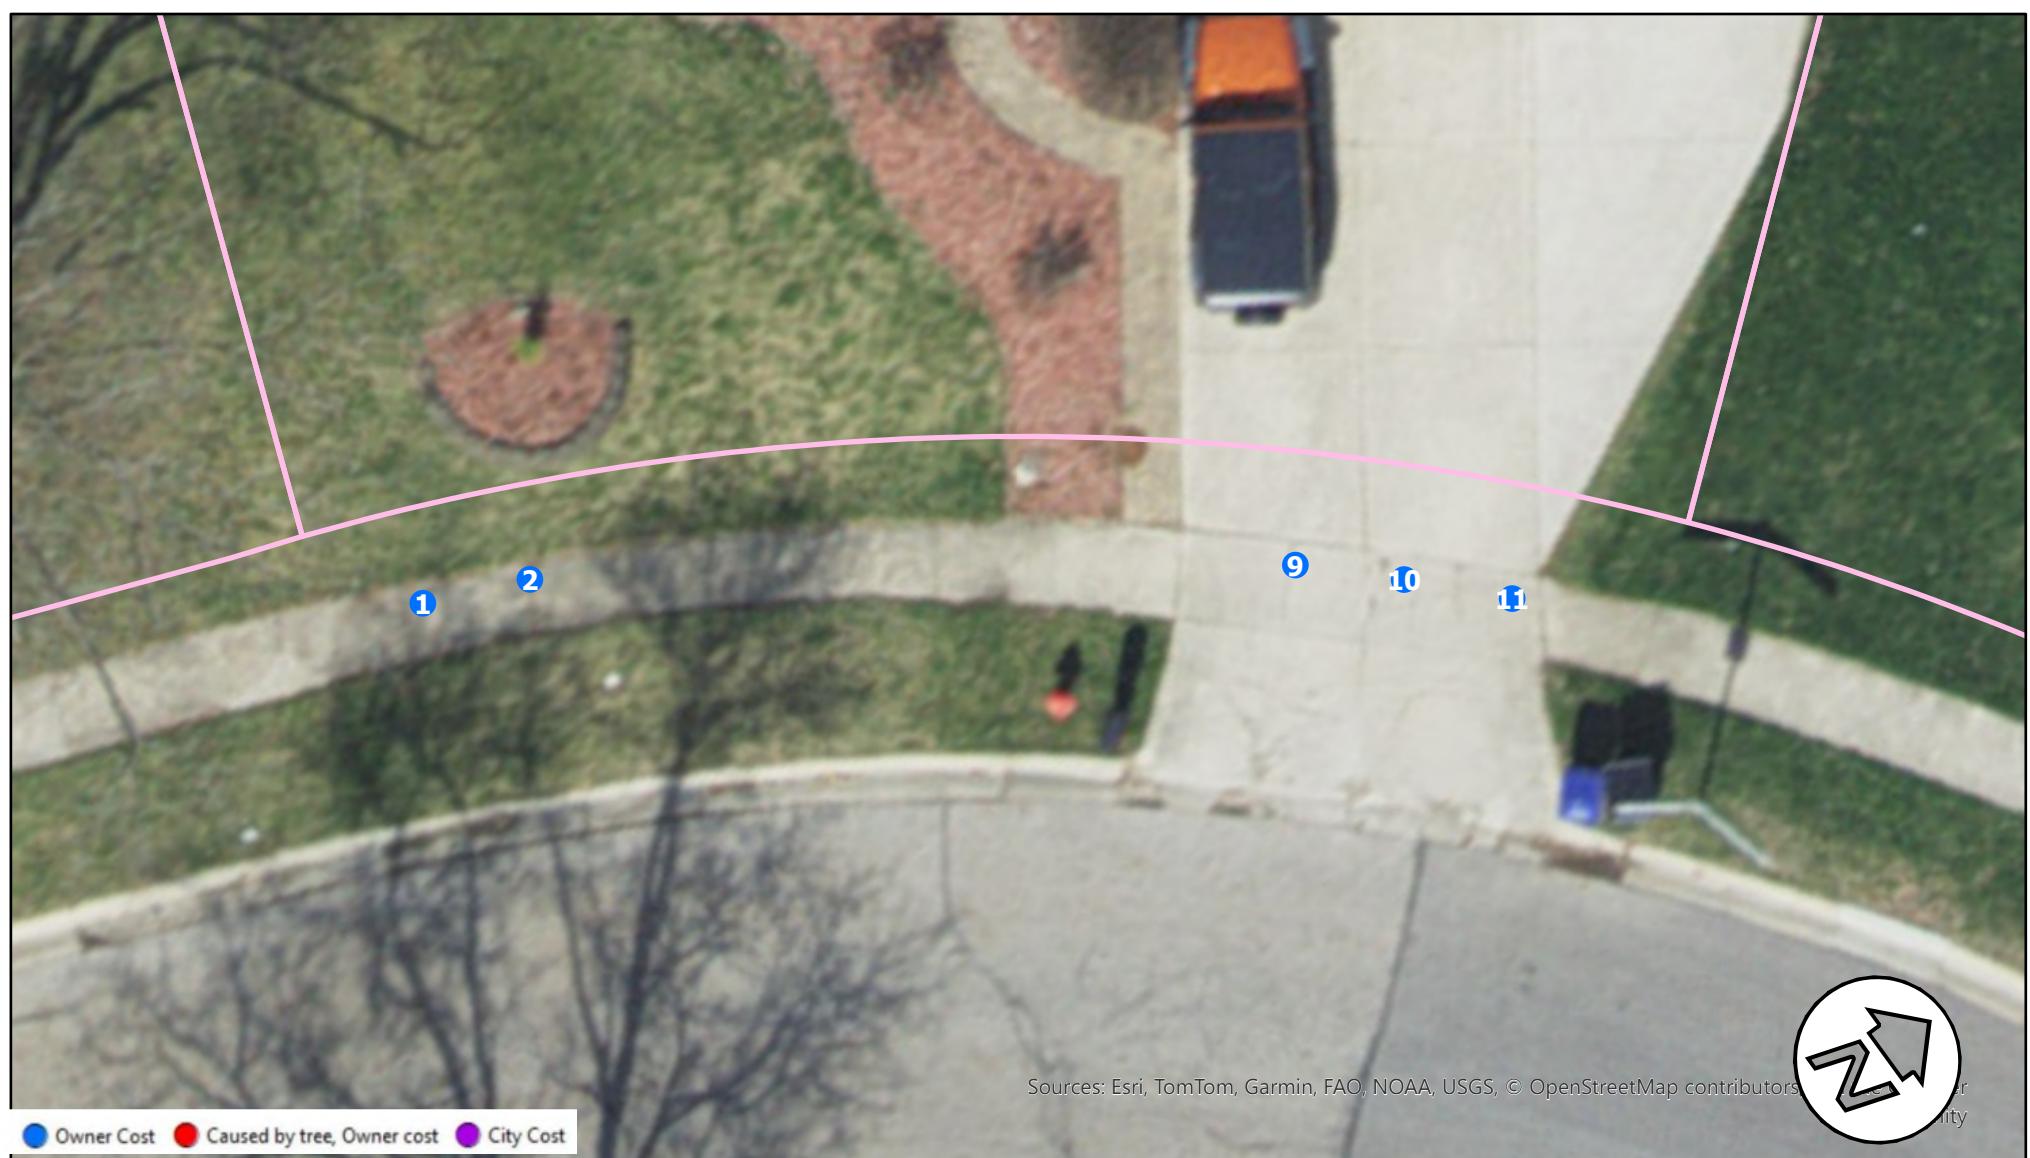
ParcelPanelNumber	Panel Type	Responsibility	Defect	4in Concrete Replacement (SF)	6in Concrete Replacement (SF)	8in Concrete Replacement (SF)	Grinding(LF)	Patch Asphalt (SF)	Patch Concrete (SF)	Vegetation (LF)	Root Pruning (Panel)
1	Sidewalk	Owner	A	20	0	0	0	0	0	0	0
2	Sidewalk	Owner	F	20	0	0	0	0	0	0	0
9	Residential Driveway	Owner	A	0	20	0	0	0	0	0	0
10	Residential Driveway	Owner	A	0	20	0	0	0	0	0	0
11	Residential Driveway	Owner	A	0	20	0	0	0	0	0	0

4" Concrete Replacement (SF)	6" Concrete Replacement (SF)	8" Concrete Replacement (SF)	Grinding (LF)	Patch Asphalt (SF)	Patch Concrete (SF)	Vegetation (LF)	ADA Ramp (ea)	Root Pruning (Panel)	Obstructions (ea)
40	60	0	0	0	0	0	0	0	0

4" Concrete Replacement Cost	6" Concrete Replacement Cost	8" Concrete Replacement Cost	Grinding Cost	Patch Asphalt Cost	Patch Concrete Cost	Vegetation Cost	ADA Ramp Cost	Root Pruning Cost	Obstruction Cost	Owner Cost	Total Cost
\$640.00	\$1,080.00	\$0.00	\$0.00	\$0.00	\$0.00	\$0.00	\$0.00	\$0.00	\$0.00	\$1,720.00	\$1,720.00
